SURVEY REPORT # 4038

Date: April 10, 2007

Vessel Name: "TANGO"

Purpose of Survey: Condition and value for pre-purchase.

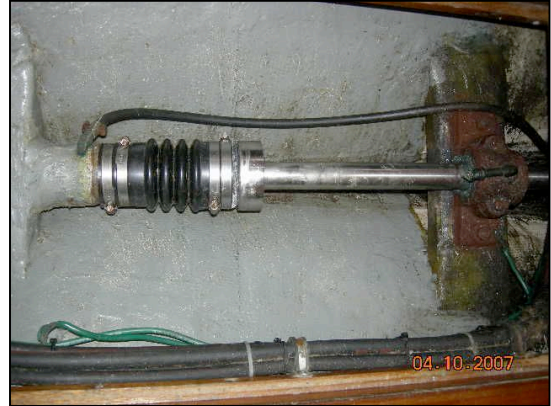
Dripless shaft seal & pillow block bearing

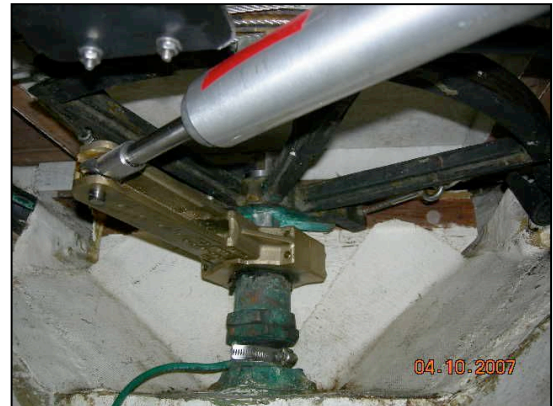
Steering assembly

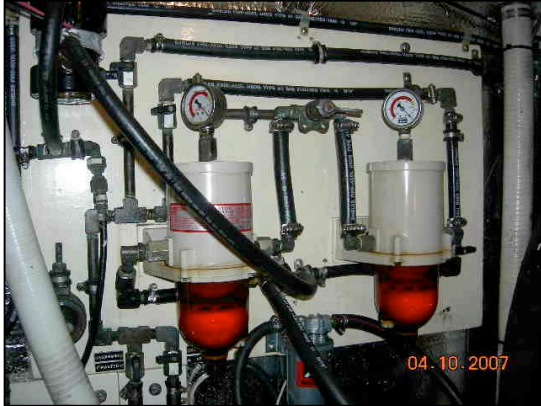
Fuel filter system

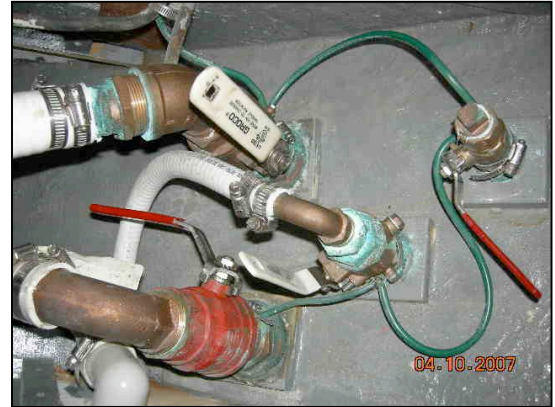
Comments: Good overall. Original stainless steel have been abandoned or cut out for installation of flexible tanks. Most of the sea valves have been replaced.

New sea valves, bonded
