SURVEY REPORT # 4038

Date: April 10, 2007

Vessel Name: "TANGO"

Purpose of Survey: Condition and value for pre-purchase.

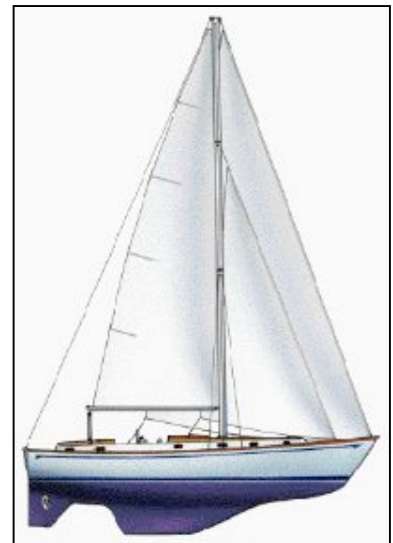
KP44 Sail Plan

Sail inventory: - Full-battened main

- Furling genoa 150%
- Furling jib 120%
- Staysail
- Trysail – no separate mast track
- Asymmetrical spinnaker with sock
